FTC-TR-71-37

**CATEGORY II AIRFRAME AND
SUBSYSTEMS EVALUATION**

UH-1N

SUBJECT ASD Addendum Report to FTC-TR-71-37, UH-1N Airframe and
Subsystems Evaluation

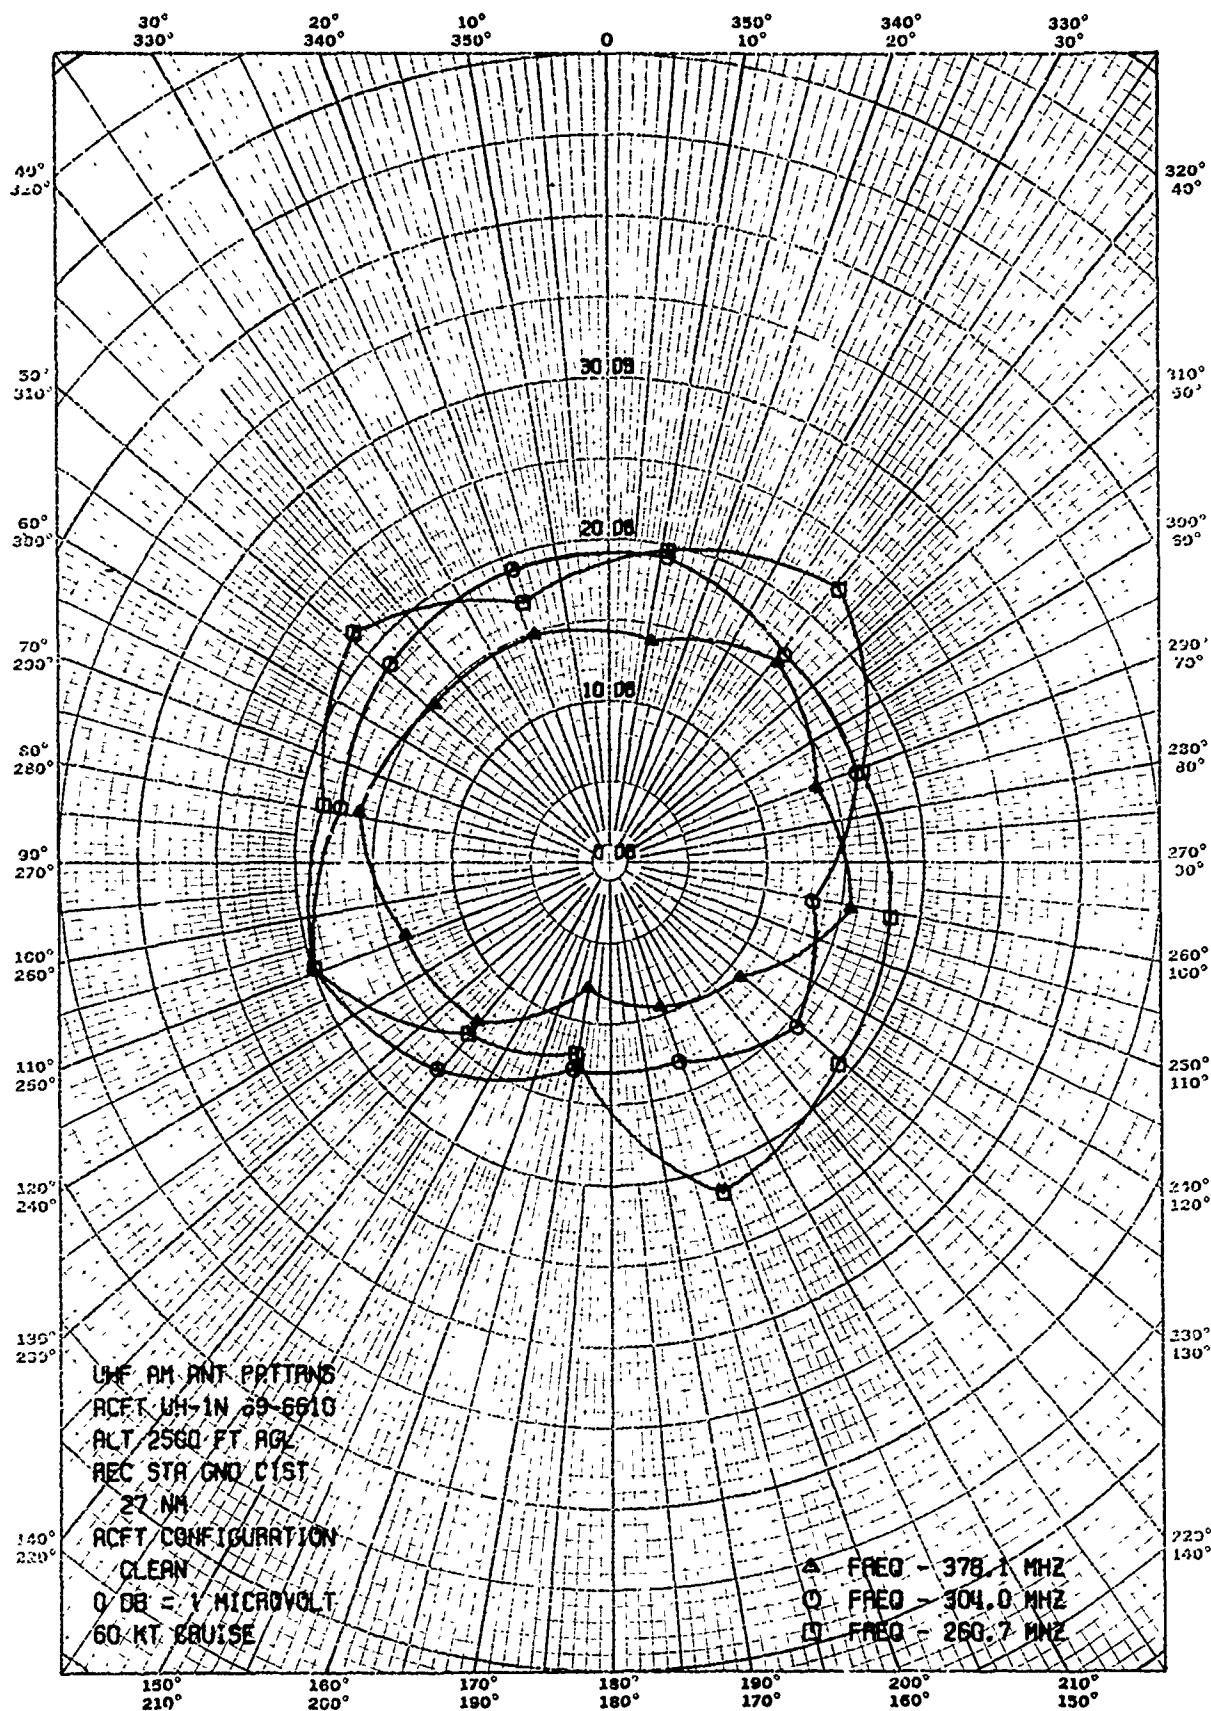
Figure 9 Post-ECP UHF-AM Antenna Patterns

Figure 9 shows the antenna radiation pattern obtained with the ARC-116 at 27 NM and 2,500 feet AGL for 260.7 mHz, 304.0 mHz, and 378.1 mHz. The radiation patterns met the required criteria and were acceptable.

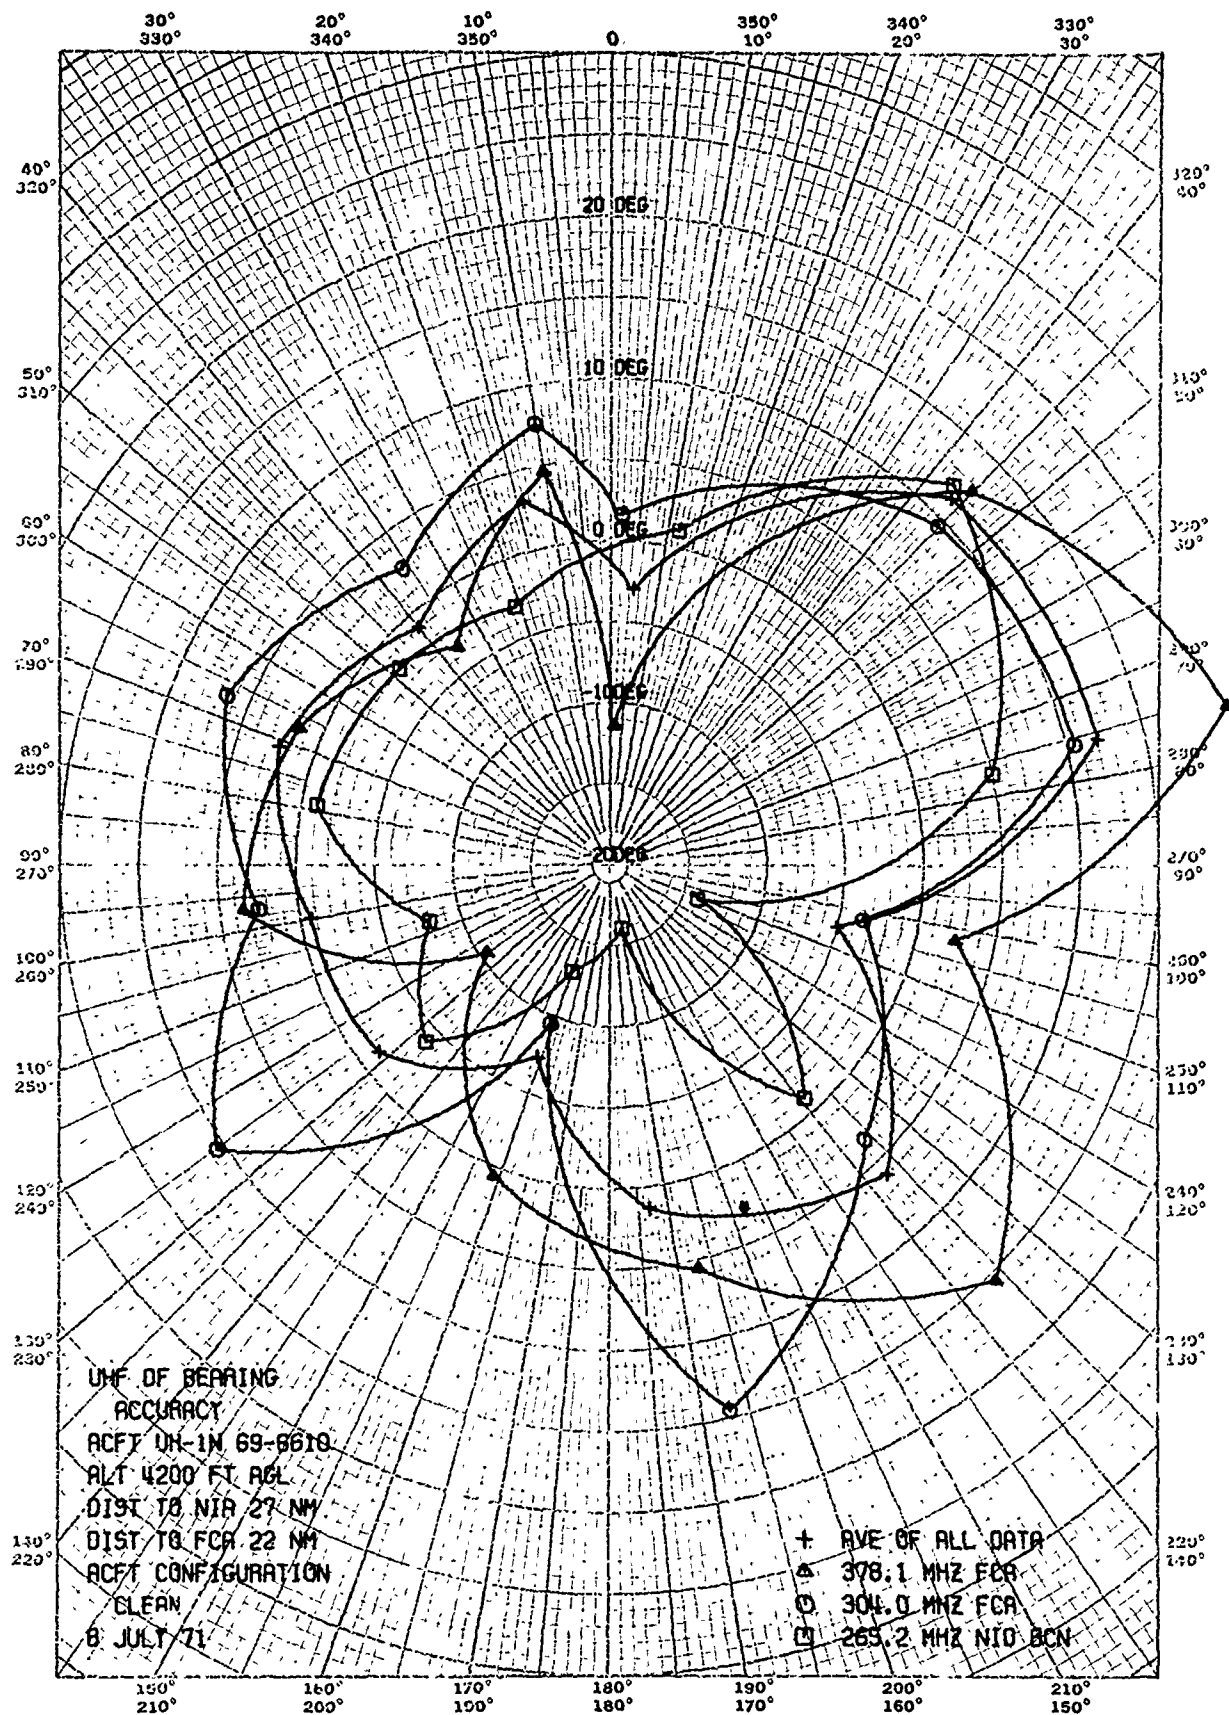
Figure 11 UHF DF Bearing Accuracy

Table XVII shows the results of the bearing accuracy tests for 265.2 MHz, 304.0 MHz, and 378.1 MHz. Figure 11 shows the UHF DF error relative to the aircraft heading. The average deviation for the three tests indicates that the error was consistently positive at 045 degrees, 076 degrees, and 136 degrees. The error was consistently negative at 010, 105, and 200 degrees. This indicated that there were disturbances due to the airframe which affected all three test frequencies. The system did not meet the bearing accuracy specifications of ± 7.00 degrees root mean square (RMS) value in MIL-D-38402, reference 18.

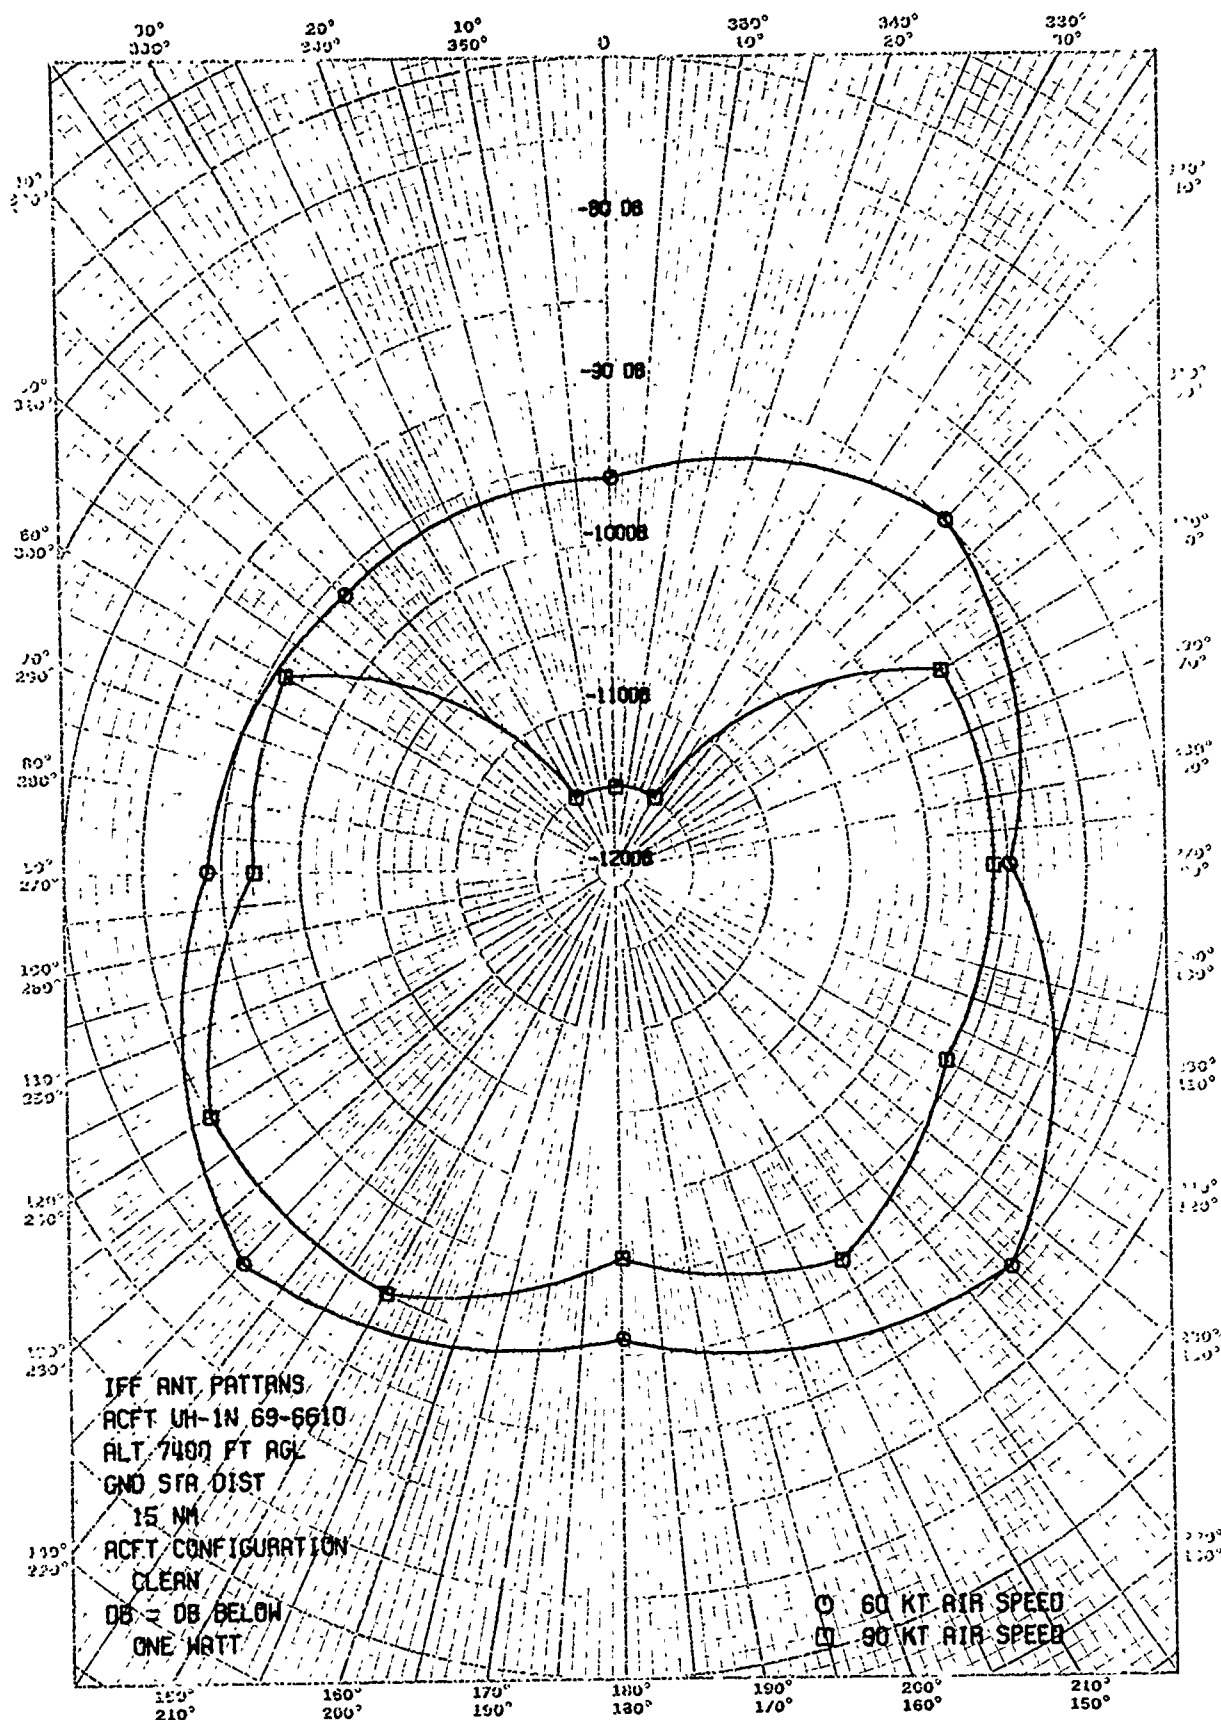
Figure 21 IFF Antenna Patterns

The radiation pattern of the AT-741A Antenna was measured by flying cloverleaf patterns over a point 15 NM from the PACF, at 10,000 feet pressure altitude. Radar tracking was used to vector the aircraft over the reference point on each heading. The relative signal strength was measured while interrogating the transponder in mode 2. The UH-1N aircraft used one IFF antenna located on the bottom of the aircraft near the rear of the fuselage. The antenna radiation pattern obtained at 90 KIAS (figure 21) was unacceptable due to the deep null off the nose of the aircraft. This null was not observed at 60 KIAS, when the nose-down attitude of the aircraft decreased approximately 4 degrees. An additional top-mounted fuselage antenna with an antenna switching unit should be installed to improve the radiation pattern. (R 31)

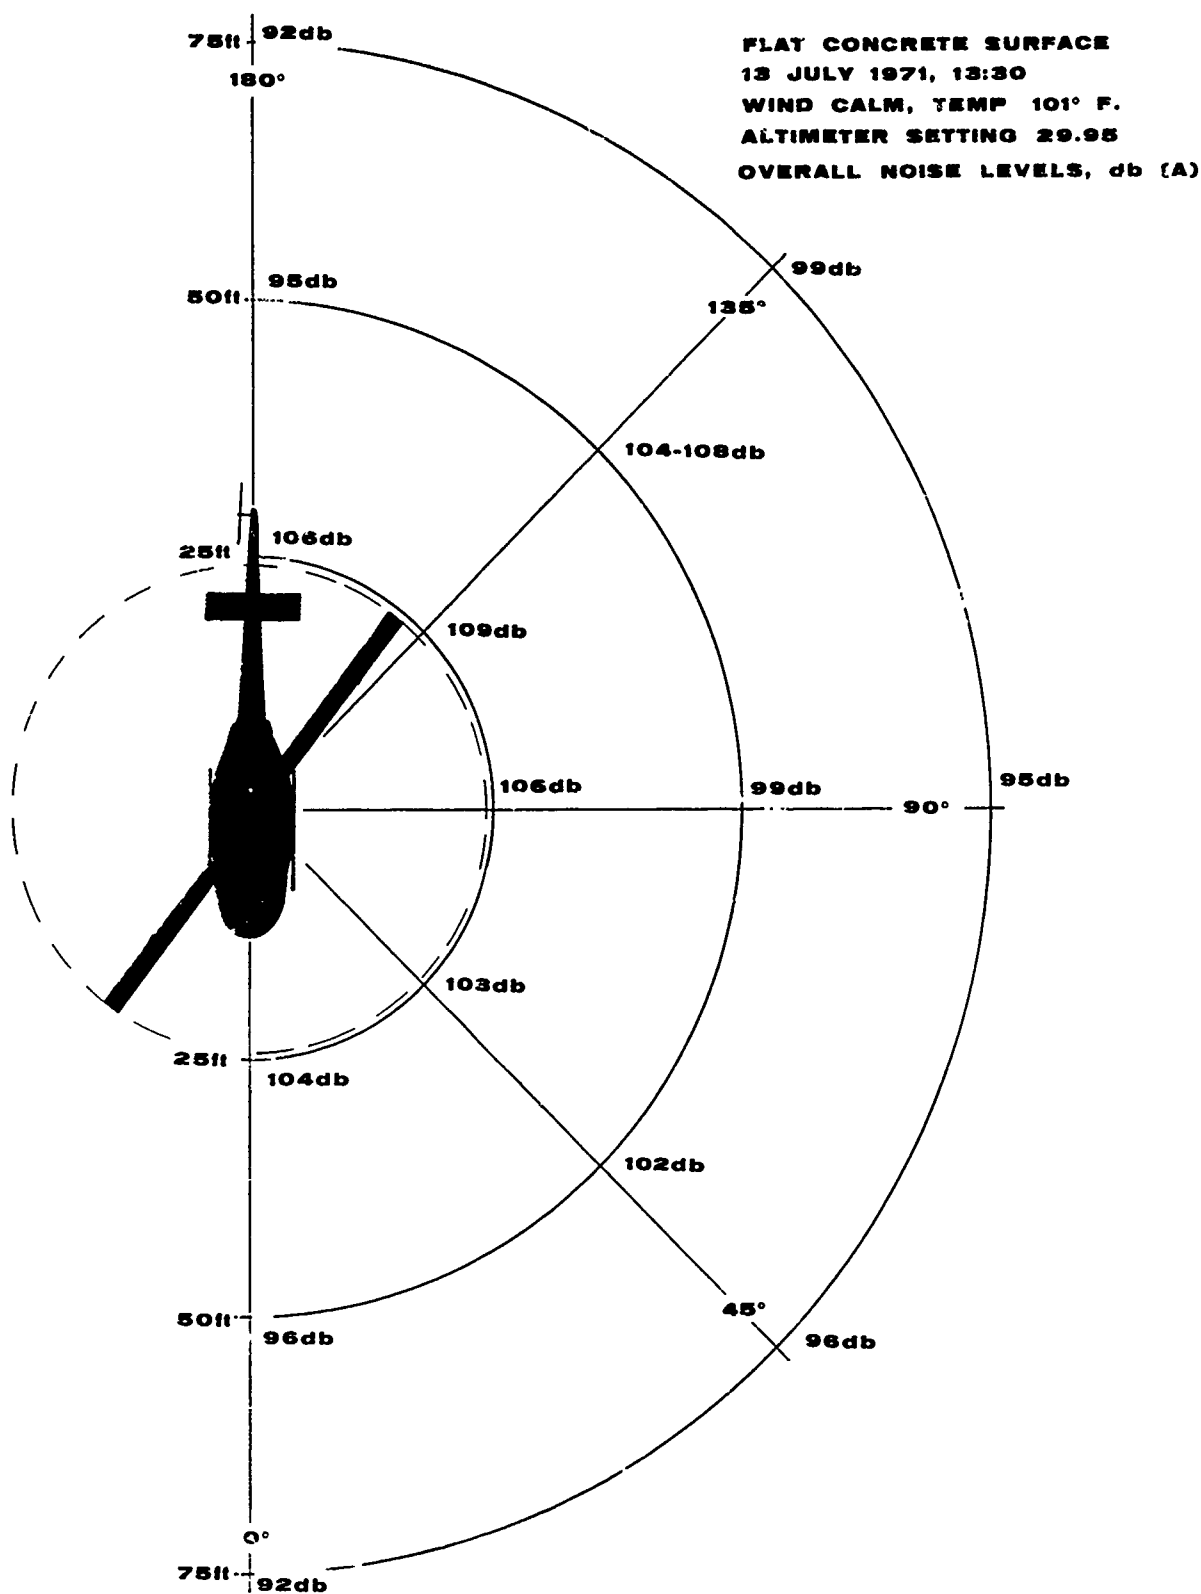
Figure 38 External Aircraft Noise Levels, Low Hover

Figure 38 illustrates overall noise levels in the area surrounding the aircraft during low level hover operations. The measurements were made with a General Radio Model 1551C overall noise level meter using the A-weighted scale. The results reflect the sound environment to which ground personnel are exposed during approach, departure, and hover conditions such as hoist operations.

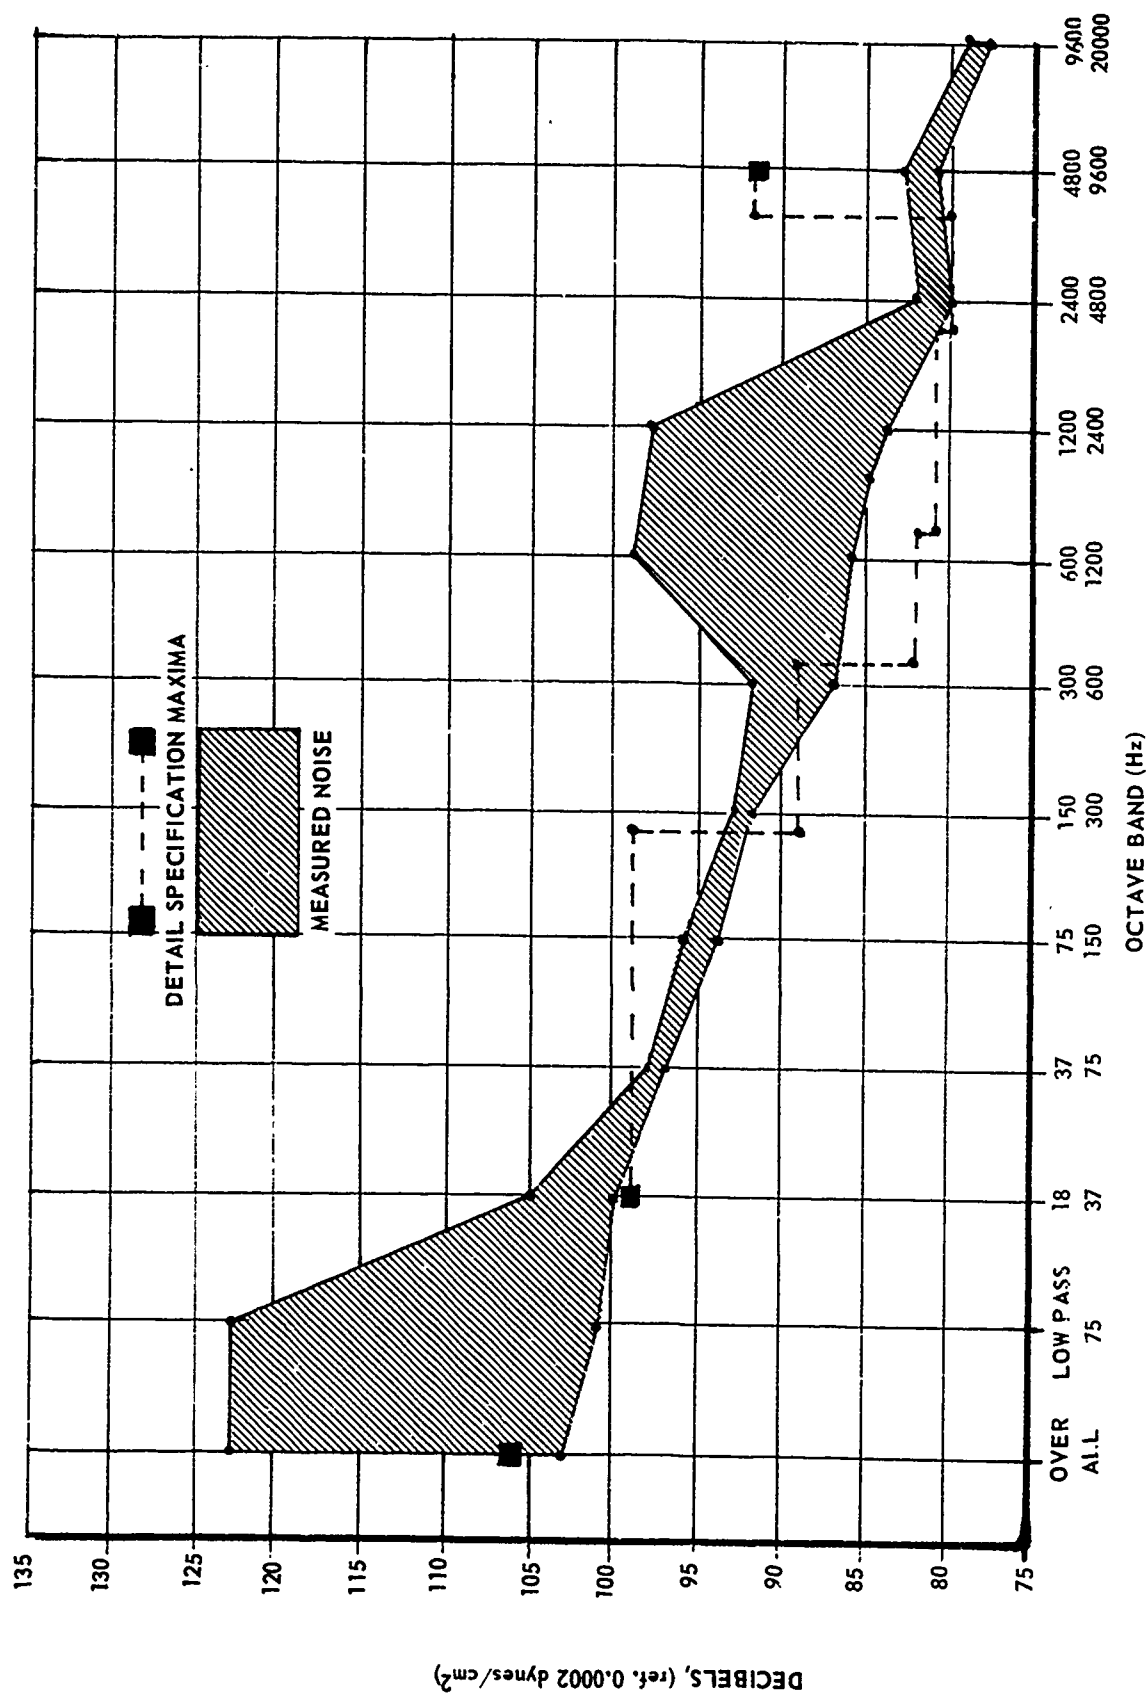
Figure 39 Comparison of Measured and Specified Noise Levels. Hover Operations

Figures 39 and 40 were prepared from the data in table XXXII to illustrate the internal noise levels compared with those in reference 27. Although internal noise levels exceeded those specified, the condition was not significant with respect to aircraft mission requirements and was not considered serious enough to warrant attempts to reduce noise levels in the aircraft. Noise levels in the 75 to 9,600 Hz frequency bands indicated that for all operations ground and flight crews should use hearing protectors in the form of sound suppressing flight helmets, earplugs, or ear muffs. The noise environment of the UH-1N was generally comparable to that of other aircraft and standard hearing conservation practices currently in use provided adequate personnel protection. (R 54)

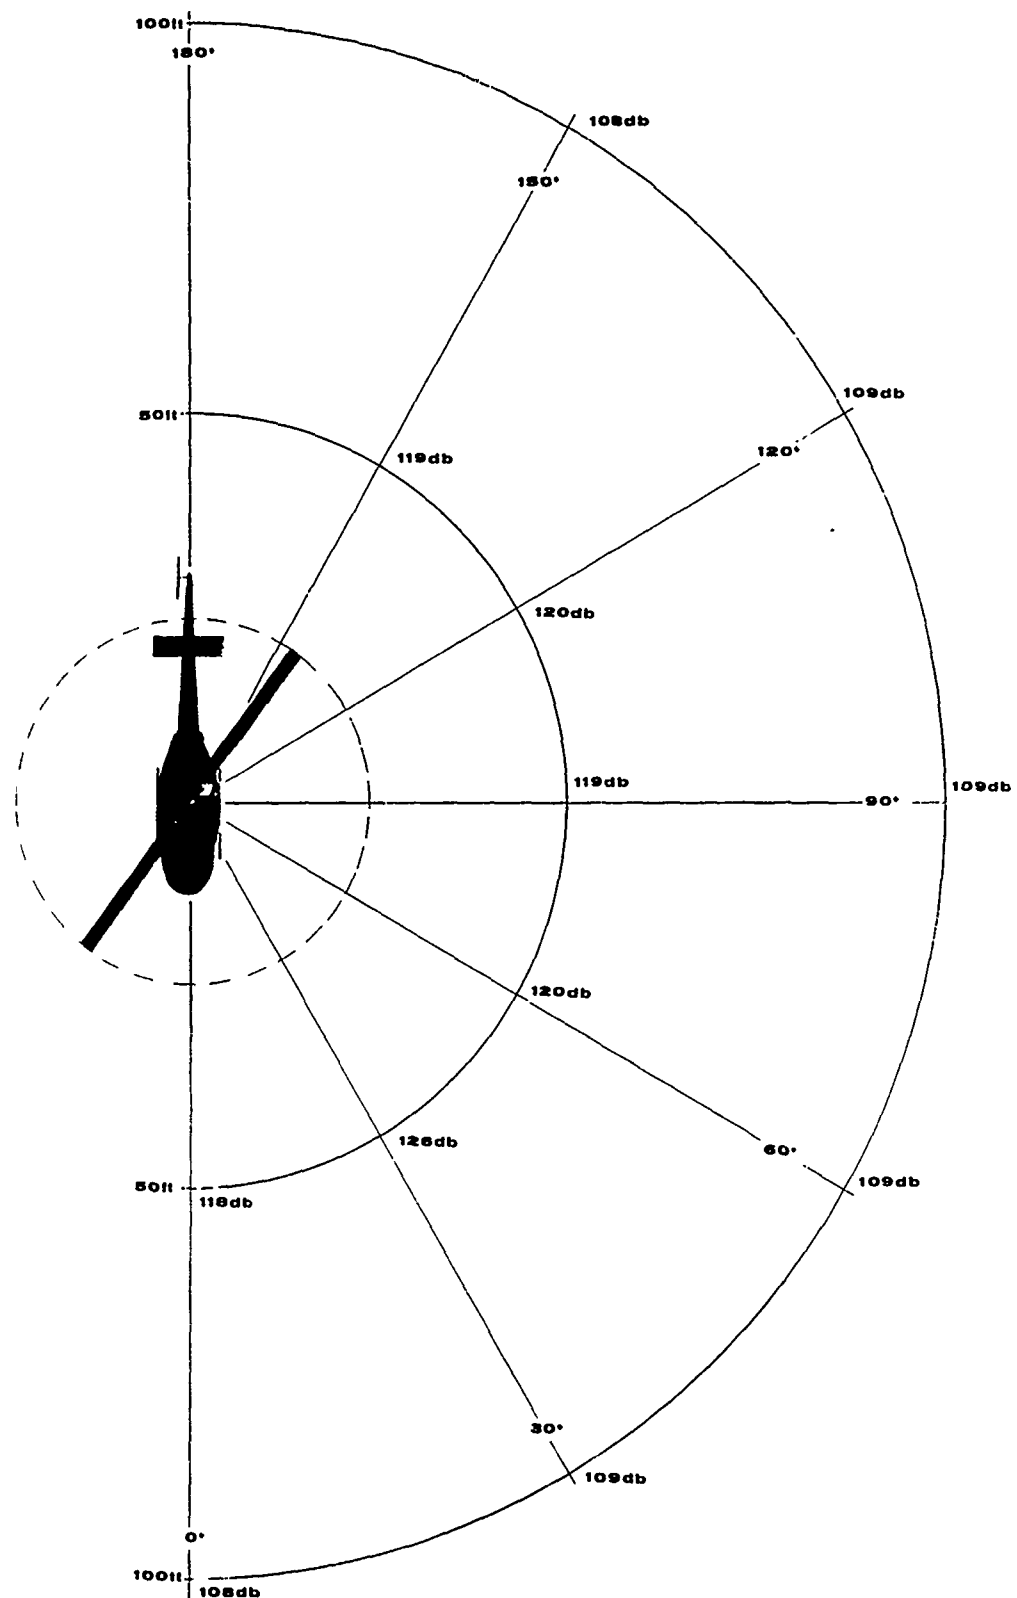
Figure 41 Loudspeaker Acoustical Energy Radiation Pattern

Figure 41 illustrates the relative power radiation pattern. The measurements were made at ground idle with a background noise level near the speaker of 115 decibels. The power setting employed was that required to produce 135 decibel signal and noise at the speaker. The sound radiation pattern close to the aircraft was most intense in the forward diagonal quadrant; however, at 100 feet no differences were observed. Inflight measurements of this type were not performed.
